U.S.-Canada Power System Outage Task Force

Final Report on the August 14, 2003 Blackout in the United States and Canada: Causes and Recommendations

April 2004

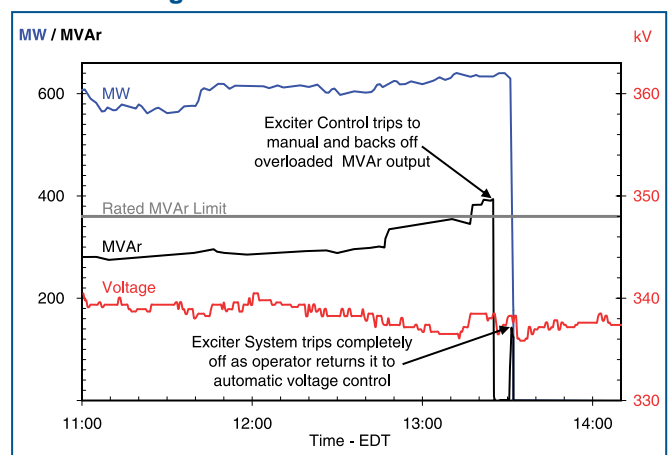
Figure 4.3. MW and MVar Output from Eastlake Unit 5 on August 14

- ◆ Eastlake Unit 5 is a 597 MW (net) generating unit located west of Cleveland on Lake Erie. It is a major source of reactive power support for the Cleveland area. It tripped at 13:31 EDT. The cause of the trip was that as the Eastlake 5 operator sought to increase the unit's reactive power output (Figure 4.3), the unit's protection system detected that VAR output exceeded the unit's VAR capability and tripped the unit off-line. The loss of the Eastlake 5 unit did not put the grid into an unreliable state—i.e., it was still able to withstand safely another contingency. However, the loss of the unit required FE to import additional power to make up for the loss of the unit's output (612 MW), made voltage management in northern Ohio more challenging, and gave FE operators less flexibility in operating their system (see details on pages 45-46 and 49-50).

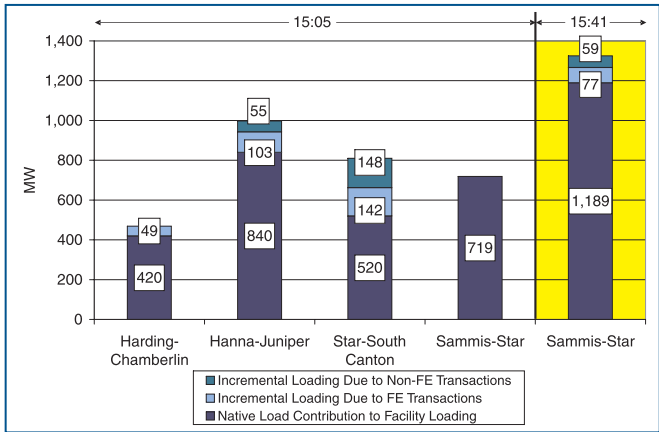
Figure 4.6. Impacts of Transactions Flows on Critical Line Loadings, August 14, 2003

According to real-time TagNet records, at 15:05 EDT the incremental flows due to transactions were approximately 2,800 MW flowing into the FirstEnergy control area and approximately 800 MW out of FE to Duquesne Light Company (DLCO). Among the flows into or out of the FE control area, the bulk of the flows were for transactions where FE was the recipient or the source—at 15:05 EDT the incremental flows due to transactions into FE were 1,300 MW from interconnections with PJM, AEP, DPL and MECS, and approximately 800 MW from interconnections with DLCO. But not all of that energy moved through the Cleveland-Akron area and across the lines which failed on August 14, as Figure 4.6 shows.

Figure 4.6 shows how all of the transactions flowing across the Cleveland-Akron area on the afternoon of August 14 affected line loadings at key FE facilities, organized by time and types of transactions. It shows that before the first transmission line failed, the bulk of the loading on the four critical FirstEnergy circuits—Harding-Chamberlin, Hanna-Juniper, Star-South Canton and Sammis-Star—was to serve Cleveland-Akron area native load. Flows to serve native load included transfers from FE’s 1,640 MW Beaver Valley nuclear power plant and its Seneca plant, both in Pennsylvania, which have been traditionally counted by FirstEnergy not as imports but rather as in-area

Recommendations
3, page 143; 23, page 160

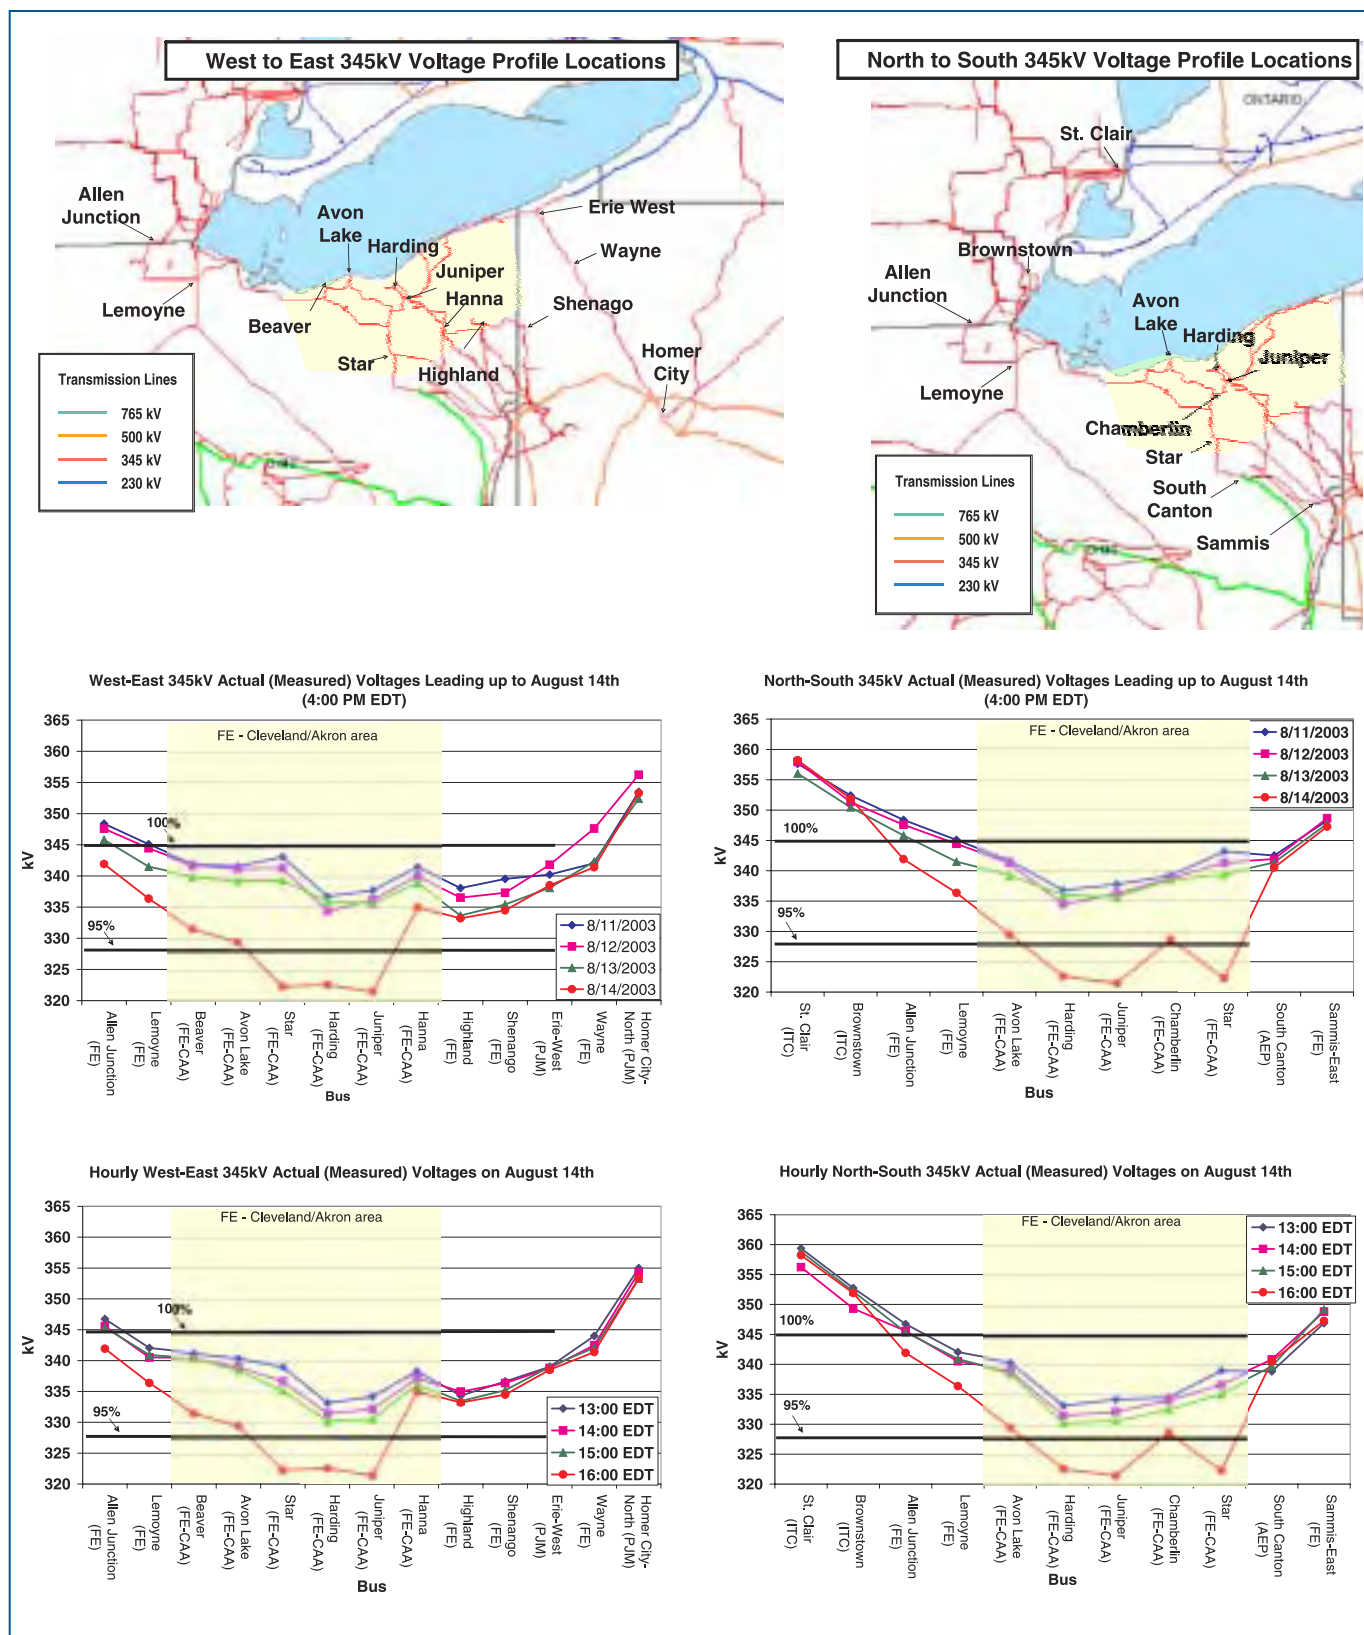
Figure 4.7. Actual Voltages Across the Ohio Area Before and On August 14, 2003

Figure 4.7 shows the profile of voltage levels at key buses from southeast Michigan across Ohio into western Pennsylvania from August 11 through 14 and for several hours on August 14. These transects show that across the area, voltage levels were consistently lower at the 345-kV buses in the Cleveland-Akron area (from Beaver to Hanna on the west to east plot and from Avon Lake to Star on the north to south plot) for the three days and the 13:00 to 15:00 EDT period preceding the blackout. Voltage was consistently and considerably higher at the outer ends of each transect, where it never dropped below 96% even on August 14. These profiles also show clearly the decline of voltage over the afternoon of August 14, with voltage at the Harding bus at 15:00 EDT just below 96% before the Harding-Chamberlin line tripped at 15:05 EDT, and dropping down to around 93% at 16:00 EDT after the loss of lines and load in the immediate area.

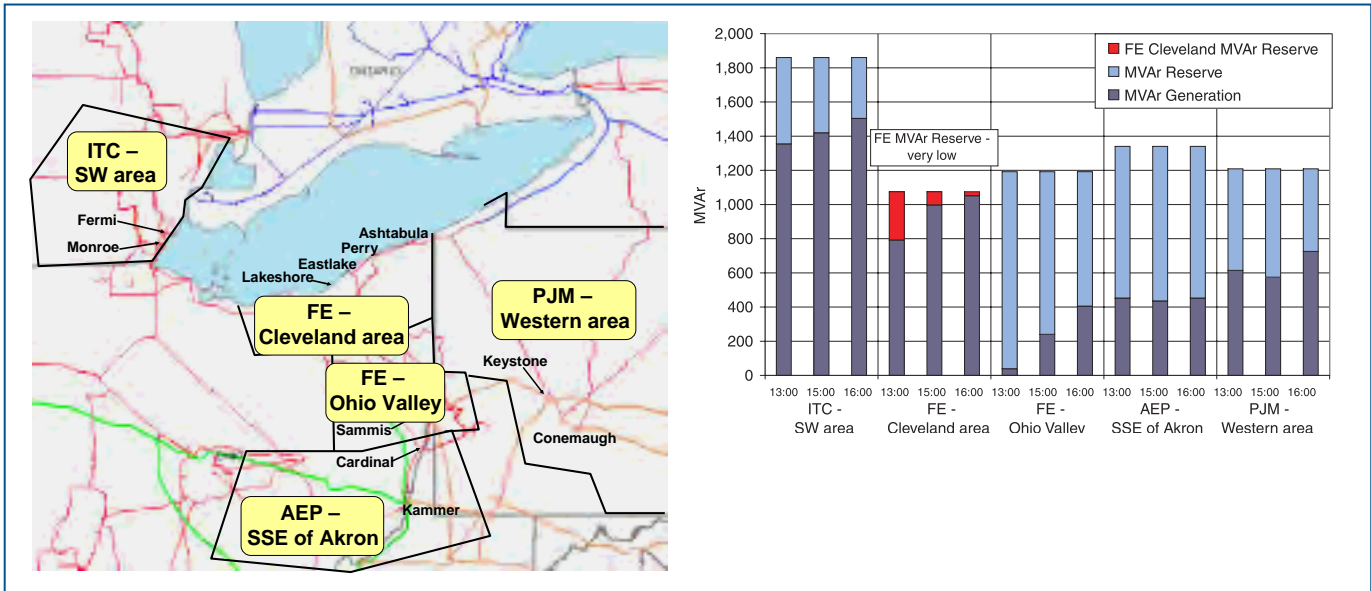
Figure 4.8. Reactive Reserves Around Ohio on August 14, 2003, for Representative Generators in the Area

Using actual data provided by FE, ITC, AEP and PJM, Figure 4.8 shows the availability of reactive reserves (the difference between reactive power generated and the maximum reactive capability) within the Cleveland-Akron area and four regions surrounding it, from ITC to PJM. On the afternoon of August 14, the graph shows that reactive power generation was heavily taxed in the Cleveland-Akron area but that extensive MVAR reserves were available in the neighboring areas. As the afternoon progressed, reactive reserves diminished for all five regions as load grew. But reactive reserves were fully depleted within the Cleveland-Akron area by 16:00 EDT without drawing down the reserves in neighboring areas, which remained at scheduled voltages. The region as a whole had sufficient reactive reserves, but because reactive power cannot be transported far but must be supplied from

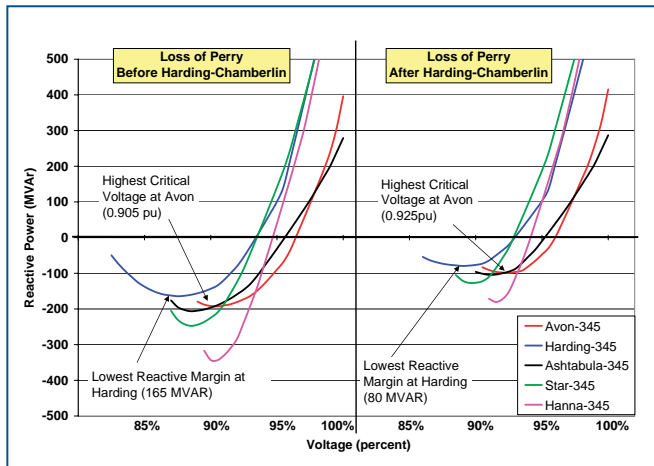
Figure 4.9. Loss of the Perry Unit Hurts Critical Voltages and Reactive Reserves: V-Q Analyses

To examine the impact of this worst contingency on the Cleveland-Akron area on August 14, Figure 4.9 shows the V-Q curves for key buses in the Cleveland-Akron area at 15:05 EDT, before and after the loss of the Harding-Chamberlin line. The curves on the left look at the impact of the loss of Perry before the Harding-Chamberlin trip, while the curves on the right show the impact had the nuclear plant been lost after Harding-Chamberlin went out of service. Had Perry gone down *before* the Harding-Chamberlin outage, reactive margins at key FE buses would have been minimal (with the tightest margin at the Harding bus, read along the Y-axis) and the critical voltage (the point before voltage collapse, read along the X-axis) at

the Avon bus would have risen to 90.5%—uncomfortably close to the limits which FE considered as an acceptable operating range. But had the Perry unit gone off-line *after* Harding-Chamberlin, reactive margins at all these buses would have been even tighter (with only 60 MVAR at the Harding bus), and critical voltage at Avon would have risen to 92.5%, worse than FE’s 90% minimum acceptable voltage. The system at this point would be very close to voltage instability. If the first line outage on August 14, 2003, had been at Hanna-Juniper rather than at Harding-Chamberlin, the FirstEnergy system could not have withstood the loss of the Perry plant.

Recommendation
23, page 160

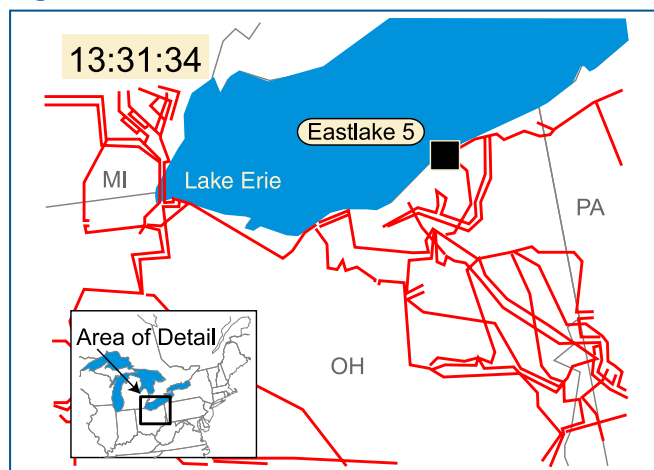
Figure 5.3. Eastlake Unit 5

Eastlake Unit 5 (rated at 597 MW) is in northern Ohio along the southern shore of Lake Erie, connected to FE's 345-kV transmission system (Figure 5.3). The Cleveland and Akron loads are generally supported by generation from a combination of the Eastlake, Perry and Davis-Besse units, along with significant imports, particularly from 9,100 MW of generation located along the Ohio and Pennsylvania border. The unavailability of

When Eastlake 5 dropped off-line, replacement power transfers and the associated reactive power to support the imports to the local area contributed to the additional line loadings in the region. At 15:00 EDT on August 14, FE's load was approximately 12,080 MW, and they were importing about 2,575 MW, 21% of their total. FE's system reactive power needs rose further.

The investigation team's system simulations indicate that the loss of Eastlake 5 was a critical step in the sequence of events. Contingency analysis simulation of the conditions following the loss of the Harding-Chamberlin 345-kV circuit at 15:05 EDT showed that the system would be unable to sustain some contingencies without line overloads above emergency ratings. However, when Eastlake 5 was modeled as in service and fully available in those simulations, all overloads above emergency limits were eliminated, even with the loss of Harding-Chamberlin.

Recommendation
23, page 160

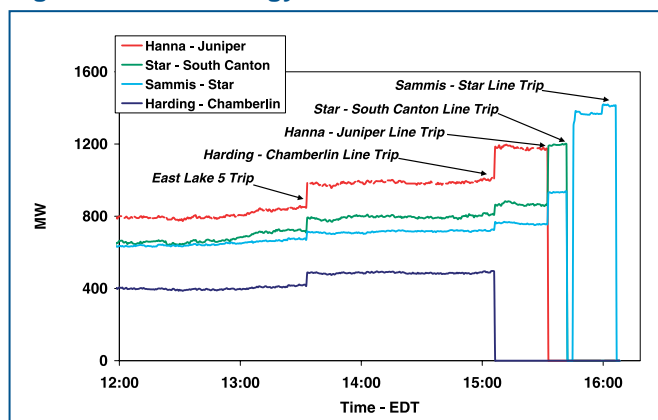
Figure 5.5. FirstEnergy 345-kV Line Flows

From 15:05:41 EDT to 15:41:35 EDT, three 345-kV lines failed with power flows at or below each transmission line's emergency rating. These line trips were not random. Rather, each was the result of a contact between a line and a tree that had grown so tall that, over a period of years, it encroached into the required clearance height for the line. As each line failed, its outage increased the loading on the remaining lines (Figure 5.5). As each of the transmission lines failed, and power flows shifted to other transmission paths, voltages on the rest of FE's system degraded further (Figure 5.6).

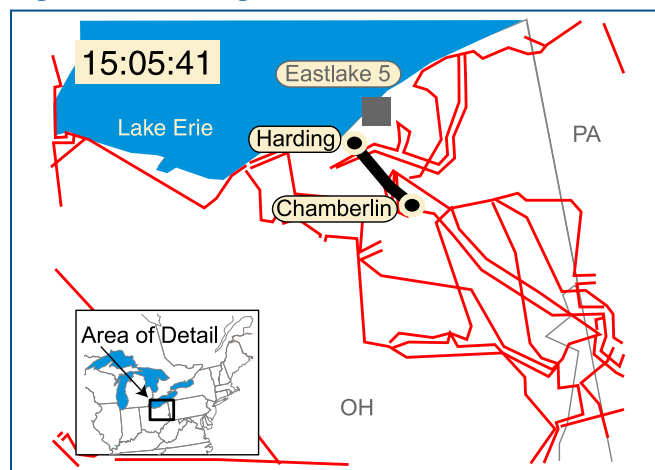
Figure 5.8. Harding-Chamberlin 345-kV Line

A short-circuit occurred on the Harding-Chamberlin 345-kV line due to a contact between the line conductor and a tree. This line failed with power flow at only 44% of its normal and emergency line rating. Incremental line current and temperature increases, escalated by the loss of Harding-Chamberlin, caused more sag on the Hanna-Juniper line, which contacted a tree and failed with power flow at 88% of its normal and emergency line rating. Star-South Canton

At 15:05:41 EDT, FE's Harding-Chamberlin line (Figure 5.8) tripped and locked out while loaded at 44% of its normal and emergency rating. At this low loading, the line temperature would not exceed safe levels—even if still air meant there

Recommendation
30, page 163

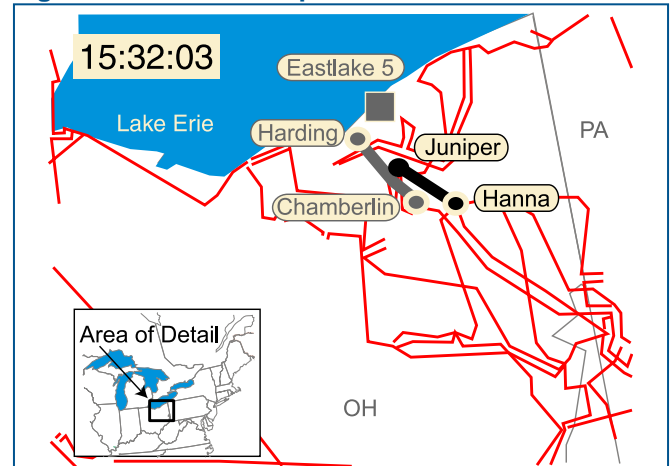
Figure 5.9. Hanna-Juniper 345-kV Line

At 15:32:03 EDT the Hanna-Juniper line (Figure 5.9) tripped and locked out. A tree-trimming crew was working nearby and observed the tree/line contact. The tree contact occurred on the south phase, which is lower than the center phase due to construction design. Although little evidence remained of the tree during the field team’s visit in October, the team observed a tree stump 14 inches (35.5 cm) in diameter at its ground line and talked to an individual who witnessed the contact on August 14.²⁶ Photographs clearly indicate that the tree was of excessive height (Figure 5.10). Surrounding trees were 18 inches (45.7 cm) in diameter at ground line and 60 feet (18.3 meters) in

Hanna-Juniper was loaded at 88% of its normal and emergency rating when it tripped. With this line open, over 1,200 MVA of power flow had to find a new path to reach its load in Cleveland. Loading on the remaining two 345-kV lines increased, with Star-Juniper taking the bulk of the power. This caused Star-South Canton's loading to rise above its normal but within its emergency rating and pushed more power onto the 138-kV system. Flows west into Michigan decreased slightly and voltages declined somewhat in the Cleveland area.

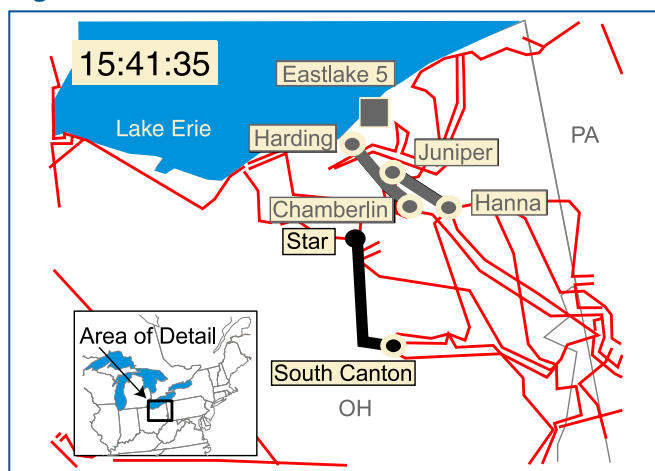
Figure 5.11. Star-South Canton 345-kV Line

The Star-South Canton line (Figure 5.11) crosses the boundary between FE and AEP—each company owns the portion of the line and manages the right-of-way within its respective territory. The Star-South Canton line tripped and reclosed three times on the afternoon of August 14, first at 14:27:15 EDT while carrying less than 55% of its emergency rating (reclosing at both ends), then at 15:38:48 and again at 15:41:33 EDT. These multiple contacts had the effect of “electric tree-trimming,” burning back the contacting limbs temporarily and allowing the line to carry more current until further sag in the still air caused the final contact and lock-out. At 15:41:35 EDT the line tripped and locked out at the Star substation, with power flow at 93% of its emergency rating. A short-circuit to ground occurred in each case.

The investigation's field team inspected the right of way in the location indicated by the relay digital fault recorders, in the FE portion of the line. They found debris from trees and vegetation that had been felled. At this location the conductor height was 44 feet 9 inches (13.6 meters). The identifiable tree remains measured 30 feet (9.1 meters) in height, although the team could not verify the location of the stump, nor find all sections of the tree. A nearby cluster of trees showed significant fault damage, including charred limbs and de-barking from fault current. Further, topsoil in

the area of the tree trunk was disturbed, discolored and broken up, a common indication of a higher magnitude fault or multiple faults. Analysis of another stump showed that a fourteen year-old tree had recently been removed from the middle of the right-of-way.²⁸

Recommendations
16, page 154; 27, page 162

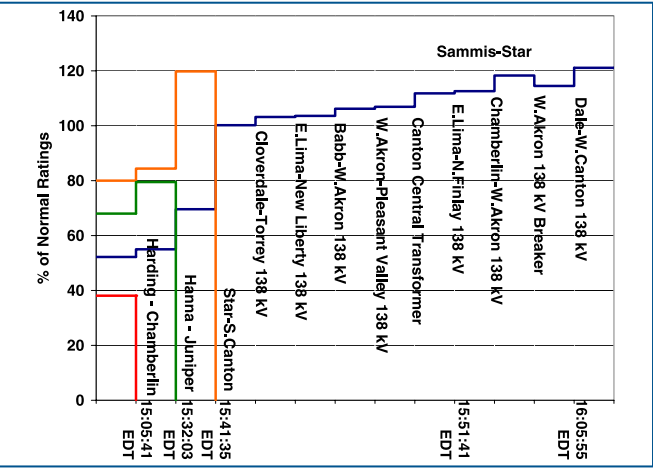
Figure 5.12. Cumulative Effects of Sequential Outages on Remaining 345-kV Lines

System impacts of the 345-kV failures. According to extensive investigation team modeling, there were no contingency limit violations as of 15:05 EDT before the loss of the Harding-Chamberlin 345-kV line. Figure 5.12 shows the line loadings estimated by investigation team modeling as the 345-kV lines in northeast Ohio began to trip. Showing line loadings on the 345-kV lines as a percent of normal rating, it tracks how the loading on each line increased as each subsequent 345-kV and 138-kV line tripped out of service between 15:05 EDT (Harding-Chamberlin, the first line above to stair-step down) and 16:06 EDT (Dale-West Canton). As the graph shows, none of the 345- or 138-kV lines exceeded their normal ratings until after the combined trips of Harding-Chamberlin and Hanna-Juniper. But immediately after the second line was lost, Star-South Canton's loading jumped from an estimated 82% of normal to 120% of normal (which was still below its emergency rating) and remained at the 120% level for 10 minutes before tripping out. To the right, the graph shows the effects of the 138-kV line failures (discussed in the next phase) upon the two remaining 345-kV lines—i.e., Sammis-Star's loading increased steadily above 100% with each succeeding 138-kV line lost.

- ◆ The Star-Juniper 345-kV line, whose loadings would exceed emergency limits if the Hanna-Juniper 345-kV line were lost; and

- ◆ The Hanna-Juniper and Harding-Juniper 345-kV lines, whose loadings would exceed emergency limits if the Perry generation unit (1,255 MW) were lost.

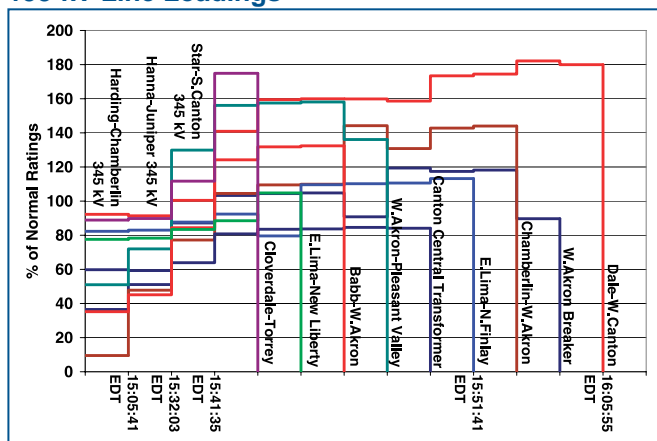
Figure 5.15. Simulated Effect of Prior Outages on 138-kV Line Loadings

dropped within the Cleveland-Akron area to restore voltage at the Star bus from 90.8% (at 120% of normal and emergency ampere rating) up to 95.9% (at 101% of normal and emergency ampere rating).⁴⁴ The P-V and V-Q analysis reviewed in Chapter 4 indicated that 95% is the minimum operating voltage appropriate for 345-kV buses in the Cleveland-Akron area. The investigation team concluded that since the Sammis-Star 345 kV outage was the critical event leading to widespread cascading in Ohio and beyond, if manual or automatic load-shedding of 1,500 MW had occurred within the Cleveland-Akron area before that outage, the blackout could have been averted.

Figure 5.15, derived from investigation team modeling, shows how the power flows shifted across FE's 345- and key 138-kV northeast Ohio lines as the line failures progressed. All lines were loaded within normal limits after the Harding-Chamberlin lock-out, but after the Hanna-Juniper trip at 15:32 EDT, the Star-South Canton 345-kV line and three 138-kV lines jumped above normal loadings. After Star-South Canton locked out at 15:41 EDT within its emergency rating, five 138-kV and the Sammis-Star 345-kV lines were overloaded. From that point, as the graph shows, each subsequent line loss increased loadings on other lines, some loading to well over 150% of normal ratings before they failed. The Sammis-Star 345-kV line stayed in service until it tripped at 16:05:57 EDT.

Recommendations
8, page 147; 21, page 158;
23, page 160

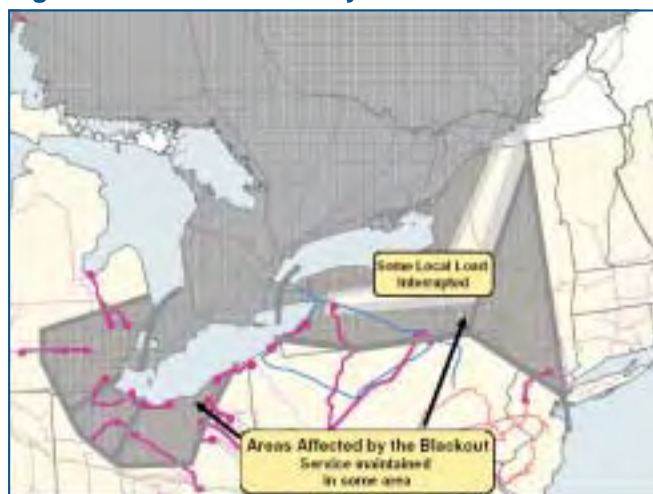
Figure 6.2. Area Affected by the Blackout

Although much of the disturbance area was fully blacked out in this process, some islands were able to reach equilibrium without total loss of service. For example, the island consisting of most of New England and the Maritime Provinces stabilized and generation and load returned to balance. Another island consisted of load in western New York and a small portion of Ontario, supported by some New York generation, the large Beck and Saunders plants in Ontario, and the 765-kV interconnection to Québec. This island survived but some other areas with large load centers within the island collapsed into a blackout condition (Figure 6.2).

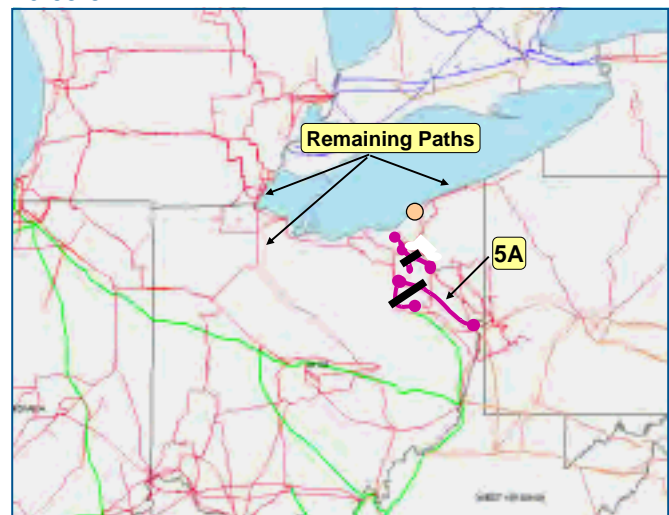
Figure 6.3. Sammis-Star 345-kV Line Trip, 16:05:57 EDT

After the loss of FE's Sammis-Star 345-kV line and the underlying 138-kV system, there were no large capacity transmission lines left from the south to support the significant amount of load in northern Ohio (Figure 6.3). This overloaded the

The Sammis-Star 345-kV line trip completely severed the 345-kV path into northern Ohio from southeast Ohio, triggering a new, fast-paced sequence of 345-kV transmission line trips in which each line trip placed a greater flow burden on those lines remaining in service. These line outages left only three paths for power to flow into western Ohio: (1) from northwest Pennsylvania to northern Ohio around the south shore of Lake Erie, (2) from southwest Ohio toward northeast Ohio, and (3) from eastern Michigan and Ontario. The line interruptions substantially weakened northeast Ohio as a source of power to eastern Michigan, making the Detroit area more reliant on 345-kV lines west and northwest of Detroit, and from northwestern Ohio to eastern Michigan. The impact of this trip was felt across the grid—it caused a 100 MW increase in flow from PJM into New York and through to Ontario.¹ Frequency in the Eastern Interconnection increased momentarily by 0.02 Hz.

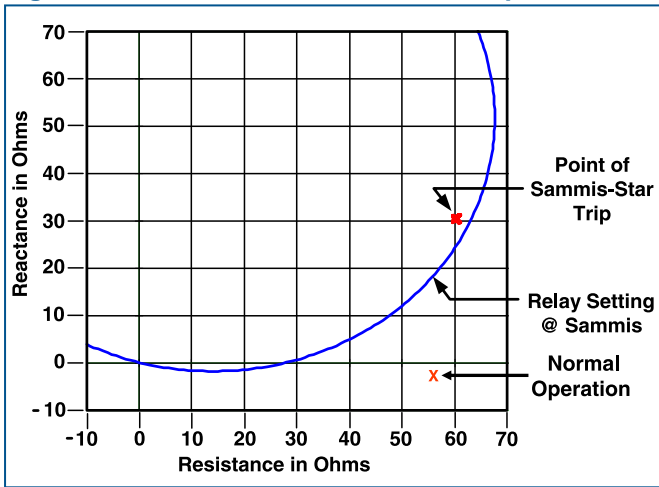
Figure 6.4. Sammis-Star 345-kV Line Trip

Sammis-Star did not trip due to a short circuit to ground (as did the prior 345-kV lines that tripped). Sammis-Star tripped due to protective zone 3 relay action that measured low apparent impedance (depressed voltage divided by abnormally high line current) (Figure 6.4). There was no fault and no major power swing at the time of the trip—rather, high flows above the line's emergency rating together with depressed voltages caused the overload to appear to the protective relays as a remote fault on the system. In effect, the relay could no longer differentiate between a remote three-phase fault and an exceptionally high line-load condition. Moreover, the reactive flows (VAr) on the line were almost ten times higher than they had been earlier in the day because of the current overload. The relay operated as it was designed to do.

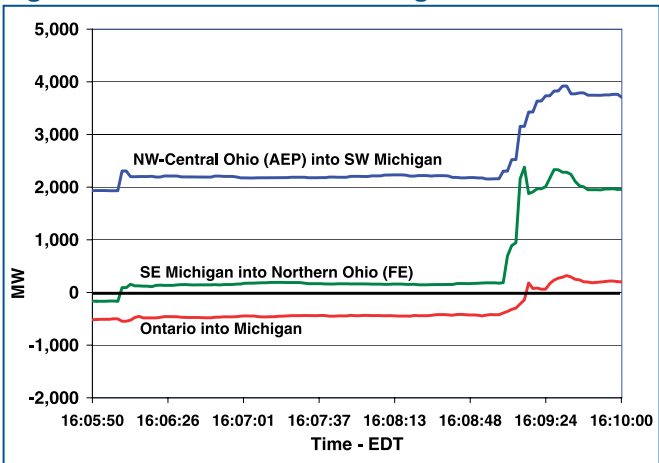
Figure 6.5. Line Flows Into Michigan

overloading and tripping within Ohio, this was happening slowly enough under relatively stable conditions that the system could readjust—after each line loss, power flows would redistribute across the remaining lines. This is illustrated in Figure 6.5, which shows the MW flows on the Michigan Electrical Coordinated Systems (MECS) interfaces with AEP (Ohio), FirstEnergy (Ohio) and Ontario. The graph shows a shift from 150 MW imports to 200 MW exports from the MECS system into FirstEnergy at 16:05:57 EDT after the loss of Sammis-Star, after which this held steady until 16:08:59, when the loss of East Lima-Fostoria Central cut the main energy path from the south and west into Cleveland and Toledo. Loss of this path was significant, causing flow from MECS into FE to jump from 200 MW up to 2,300 MW, where it bounced somewhat before stabilizing, roughly, until the path across Michigan was cut at 16:10:38 EDT.

Note: These curves use data collected from the MECS Energy Management System, which records flow quantities every 2 seconds. As a result, the fast power swings that occurred between 16:10:36 to 16:13 were not captured by the recorders and are not reflected in these curves.

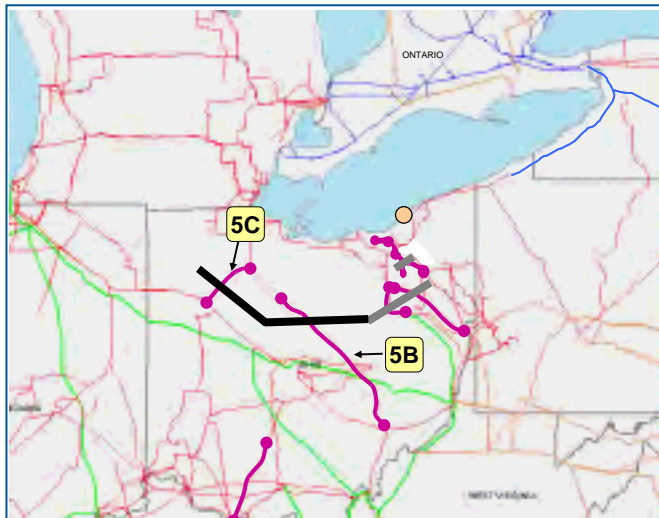
Figure 6.6. Ohio 345-kV Lines Trip, 16:08:59 to 16:09:07 EDT

345-kV transmission lines removed the transmission paths from southern and western Ohio into northern Ohio and eastern Michigan. Northern Ohio was connected to eastern Michigan by only three 345-kV transmission lines near the southwestern bend of Lake Erie. Thus, the combined northern Ohio and eastern Michigan load centers were left connected to the rest of the grid only by: (1) transmission lines eastward from northeast Ohio to northwest Pennsylvania along the southern shore of Lake Erie, and (2) westward by lines west and northwest of Detroit, Michigan and from Michigan into Ontario (Figure 6.6).

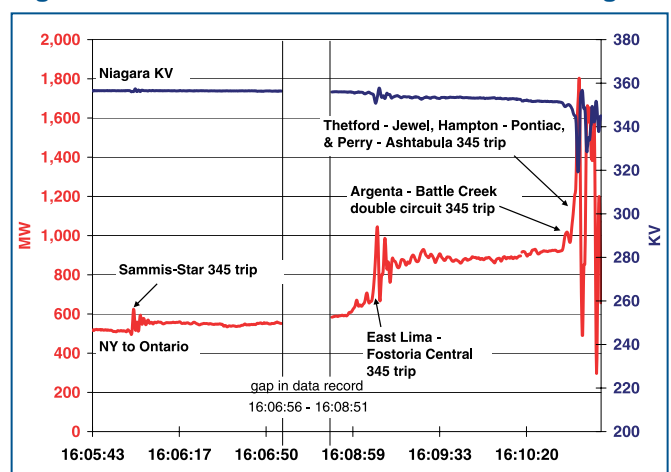
Figure 6.7. New York-Ontario Line Flows at Niagara

Figure 6.7, a high-speed recording of 345-kV flows past Niagara Falls from the Hydro One recorders,

shows the impact of the East Lima-Fostoria Central and the New York to Ontario power swing, which continued to oscillate for over 10 seconds. Looking at the MW flow line, it is clear that when Sammis-Star tripped, the system experienced oscillations that quickly damped out and rebalanced. But East Lima-Fostoria triggered significantly greater oscillations that worsened in magnitude for several cycles, and returned to stability but continued to flutter until the Argenta-Battle Creek trip 90 seconds later. Voltages also began declining at this time.

Figure 6.7 also shows the magnitude of subsequent flows and voltages at the New York-Ontario Niagara border, triggered by the trips of the Argenta-Battle Creek, Argenta-Tompkins, Hampton-Pontiac and Thetford-Jewell 345-kV lines in Michigan, and the Erie West-Ashtabula-Perry

As the cascade progressed beyond Ohio, it spread due not to insufficient reactive power and a voltage collapse, but because of dynamic power swings and the resulting system instability. Figure 6.7 shows voltage levels recorded at the Niagara area. It shows clearly that voltage levels remained stable until 16:10:30 EDT, despite significant power fluctuations. In the cascade that followed, the voltage instability was a companion to, not a driver of, the angle instability that tripped generators and lines.

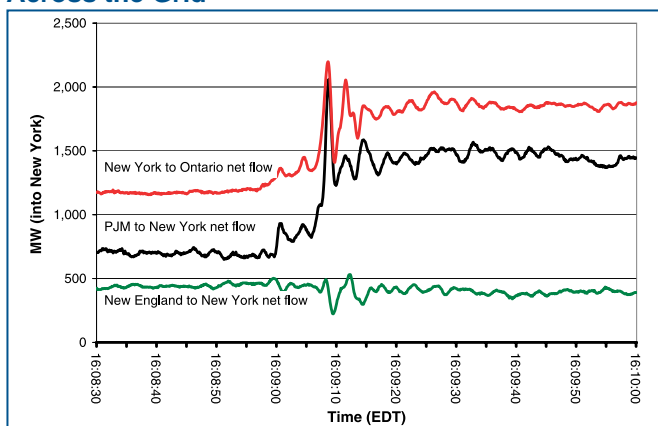
Figure 6.8. First Power Swing Has Varying Impacts Across the Grid

Figure 6.8, of metered power flows along the New York interfaces, documents how the flows heading north and west toward Detroit and Cleveland varied at different points on the grid. Beginning at 16:09:05 EDT, power flows jumped simultaneously across all three interfaces—but when the first power surge peaked at 16:09:09, the change in flow was highest on the PJM interface and lowest on the New England interface. Power flows increased significantly on the PJM-NY and NY-Ontario interfaces because of the redistribution of flow around Lake Erie. The New England and Maritime systems maintained the same generation to load balance and did not carry the redistributed flows because they were not in the direct path of the flows, so that interface with New York showed little response.

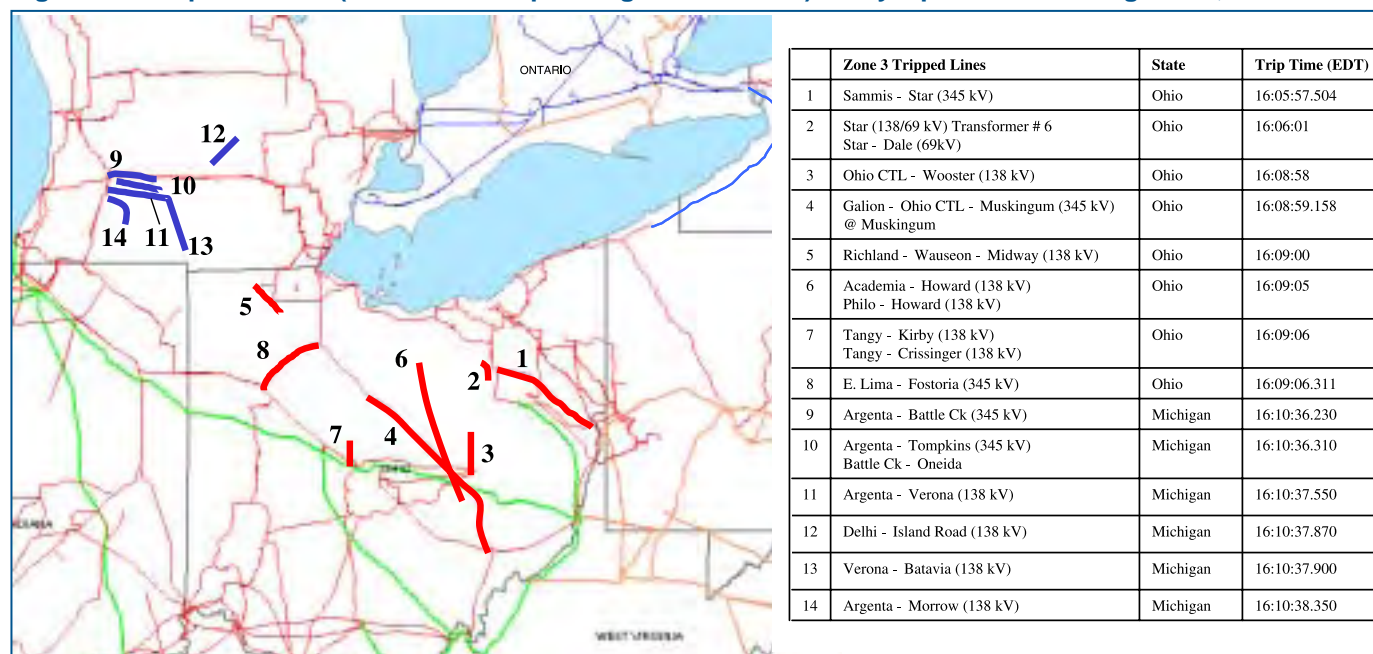
Figure 6.9. Map of Zone 3 (and Zone 2s Operating Like Zone 3s) Relay Operations on August 14, 2003

The Sammis-Star line tripped at 16:05:57 EDT on a zone 3 impedance relay although there were no faults occurring at the time, because increased real and reactive power flow caused the apparent impedance to be within the impedance circle (reach) of the relay. Between 16:06:01 and 16:10:38.6 EDT, thirteen more important 345 and 138-kV lines tripped on zone 3 operations that afternoon at the start of the cascade, including Galion-Ohio Central-Muskingum, East Lima-Fostoria Central, Argenta-Battle Creek, Argenta-Tompkins, Battle Creek-Oneida, and Perry-Ashtabula (Figure 6.9). These included several zone 2 relays in Michigan that had been set to operate like zone 3s, overreaching the line by more than 200% with no intentional time delay for remote breaker failure protection.³ All of these relays operated according to their settings. However, the zone 3 relays (and zone 2 relays acting like zone 3s) acted so quickly that they impeded the natural ability of the electric system to hold together, and did not allow for any operator intervention to attempt to stop the spread of the cascade. The investigation team concluded that because these zone 2 and 3 relays tripped after each line overloaded, these relays were the common mode of failure that accelerated the geographic spread of the cascade. Given grid conditions and loads and the limited operator tools available, the speed of the zone 2 and 3 operations across Ohio and Michigan eliminated any possibility after 16:05:57 EDT that either operator action or automatic intervention could have limited or mitigated the growing cascade.

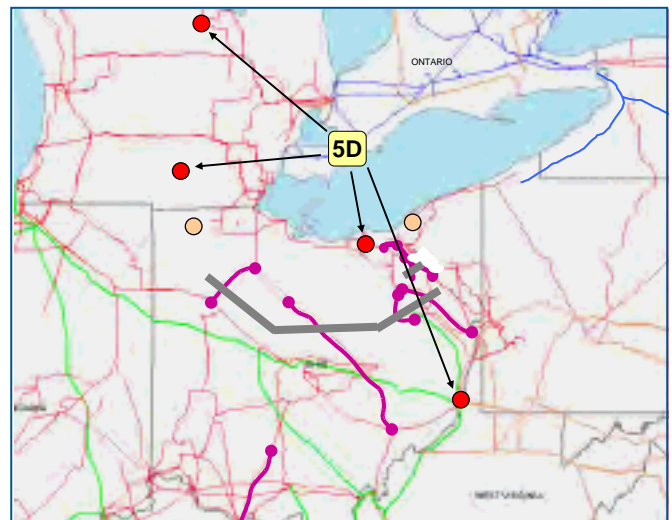
Figure 6.10. Michigan and Ohio Power Plants Trip

The Burger units tripped after the 138-kV lines into the Burger 138-kV substation (Ohio) tripped from the low voltages in the Cleveland area (Figure 6.10). The MCV plant is in central Michigan. Kinder Morgan is in south-central Michigan. The Kinder-Morgan units tripped due to a transformer fault and one due to over-excitation.

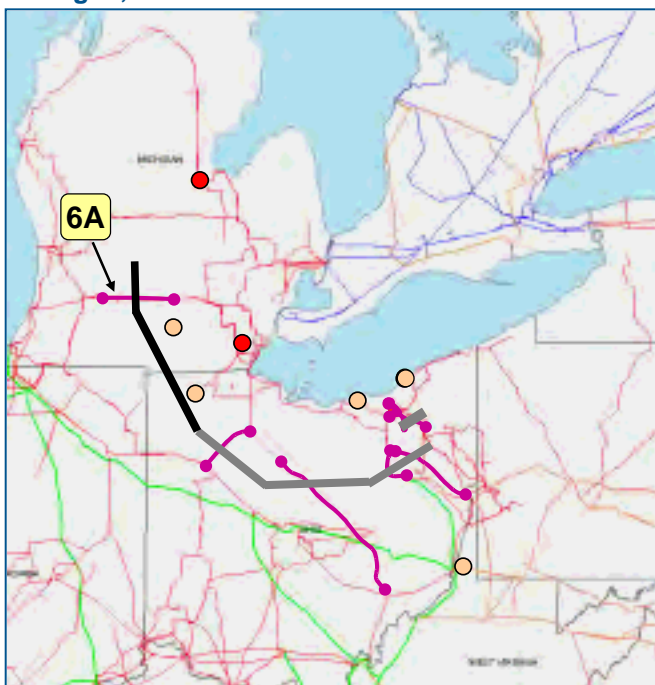
Figure 6.11. Transmission and Generation Trips in Michigan, 16:10:36 to 16:10:37 EDT

under-voltage on the system. Michigan lines west of Detroit then began to trip, as shown in Figure 6.11.

The Argenta-Battle Creek relay first opened the line at 16:10:36.230 EDT, reclosed it at 16:10:37, then tripped again. This line connects major generators—including the Cook and Palisades nuclear plants and the Campbell fossil plant—to the MECS system. This line is designed with auto-reclose breakers at each end of the line, which do an automatic high-speed reclose as soon as they open to restore the line to service with no interruptions. Since the majority of faults on the North American grid are temporary, automatic reclosing can enhance stability and system reliability. However, situations can occur when the power systems behind the two ends of the line could go out of phase during the high-speed reclose period (typically less than 30 cycles, or one half second, to allow the air to de-ionize after the trip to prevent arc re-ignition). To address this and protect generators from the harm that an out-of-synchronism reconnect could cause, it is worth studying whether a synchro-check relay is needed, to reclose the second breaker only when the two ends are within a certain voltage and phase angle tolerance. No such protection was installed at Argenta-Battle Creek; when the line reclosed, there was a 70° difference in phase across the circuit breaker reclosing the line. There

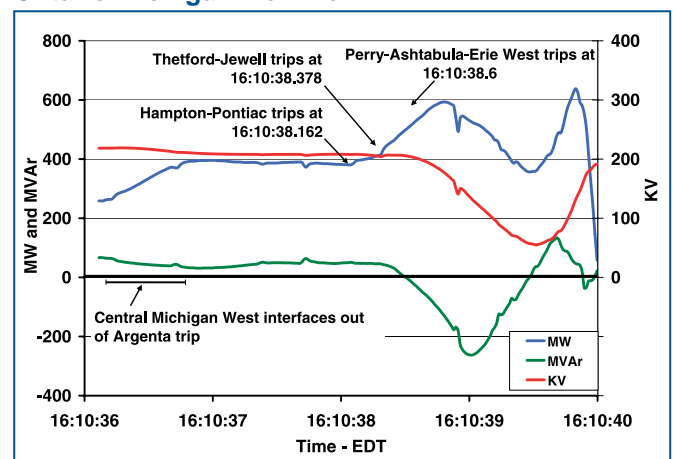
Figure 6.12. Flows on Keith-Waterman 230-kV Ontario-Michigan Tie Line

The Power System Disturbance Recorders at Keith and Lambton, Ontario, captured these events in the flows across the Ontario-Michigan interface, as shown in Figure 6.12 and Figure 6.16. It shows clearly that the west to east Michigan separation (the Thetford-Jewell trip) was the start and Erie West-Ashtabula-Perry was the trigger for the 3,700 MW surge from Ontario into Michigan. When Thetford-Jewell tripped, power that had been flowing into Michigan and Ohio from western Michigan, western Ohio and Indiana was cut off. The nearby Ontario recorders saw a pronounced impact as flows into Detroit readjusted to draw power from the northeast instead. To the south,

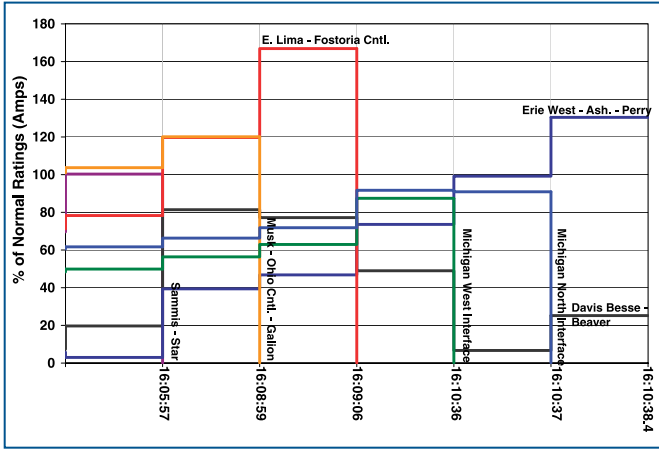
Figure 6.13. Simulated 345-kV Line Loadings from 16:05:57 through 16:10:38.4 EDT

Figures 6.13 and 6.14 show the results of investigation team modeling of the line loadings on the Ohio, Michigan, and other regional interfaces for the period between 16:05:57 until the Thetford-Jewell trip, to understand how power flows shifted during this period. The team simulated evolving system conditions on August 14, 2003, based on the 16:05:50 power flow case developed by the MAAC-ECAR-NPCC Operations Studies Working Group. Each horizontal line in the graph indicates a single or set of 345-kV lines and its loading as a function of normal ratings over time as first one, then another, set of circuits tripped out of service. In general, each subsequent line trip causes the remaining line loadings to rise; where a line drops (as Erie West-Ashtabula-Perry in Figure 6.13 after the Hanna-Juniper trip), that indicates that line loading lightened, most likely due to customers dropped from service. Note that Muskingum and East Lima-Fostoria Central were overloaded before they tripped, but the Michigan west and north interfaces were not overloaded before they tripped. Erie West-Ashtabula-Perry was loaded to 130% after the Hampton-Pontiac and Thetford-Jewell trips.

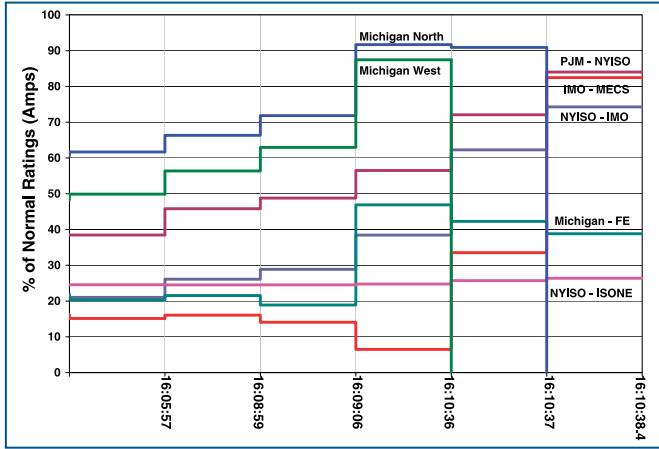
Figure 6.14. Simulated Regional Interface Loadings from 16:05:57 through 16:10:38.4 EDT

The Regional Interface Loadings graph (Figure 6.14) shows that loadings at the interfaces between PJM-NY, NY-Ontario and NY-New England were well within normal ratings before the east-west Michigan separation.

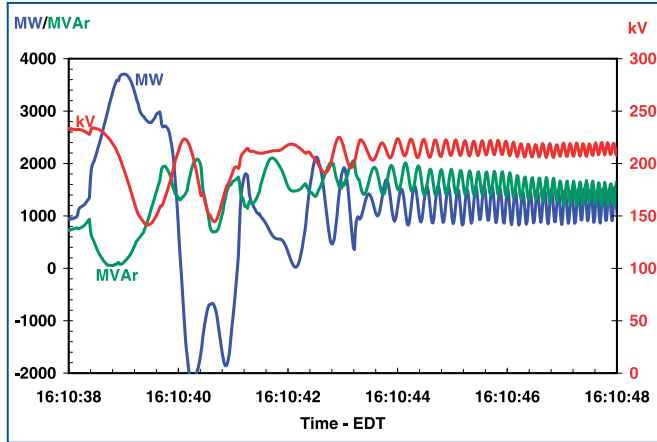
Figure 6.16. Active and Reactive Power and Voltage from Ontario into Detroit

This was a power surge of large magnitude, so frequency was not the same across the Eastern Interconnection. As Figure 6.16 shows, the power swing resulted in a rapid rate of voltage decay. Flows into Detroit exceeded 3,700 MW and 1,500 MVAR—the power surge was draining real power out of the northeast, causing voltages in Ontario and New York to drop. At the same time, local voltages in the Detroit area were plummeting because Detroit had already lost 500 MW of local generation. Detroit would soon lose synchronism

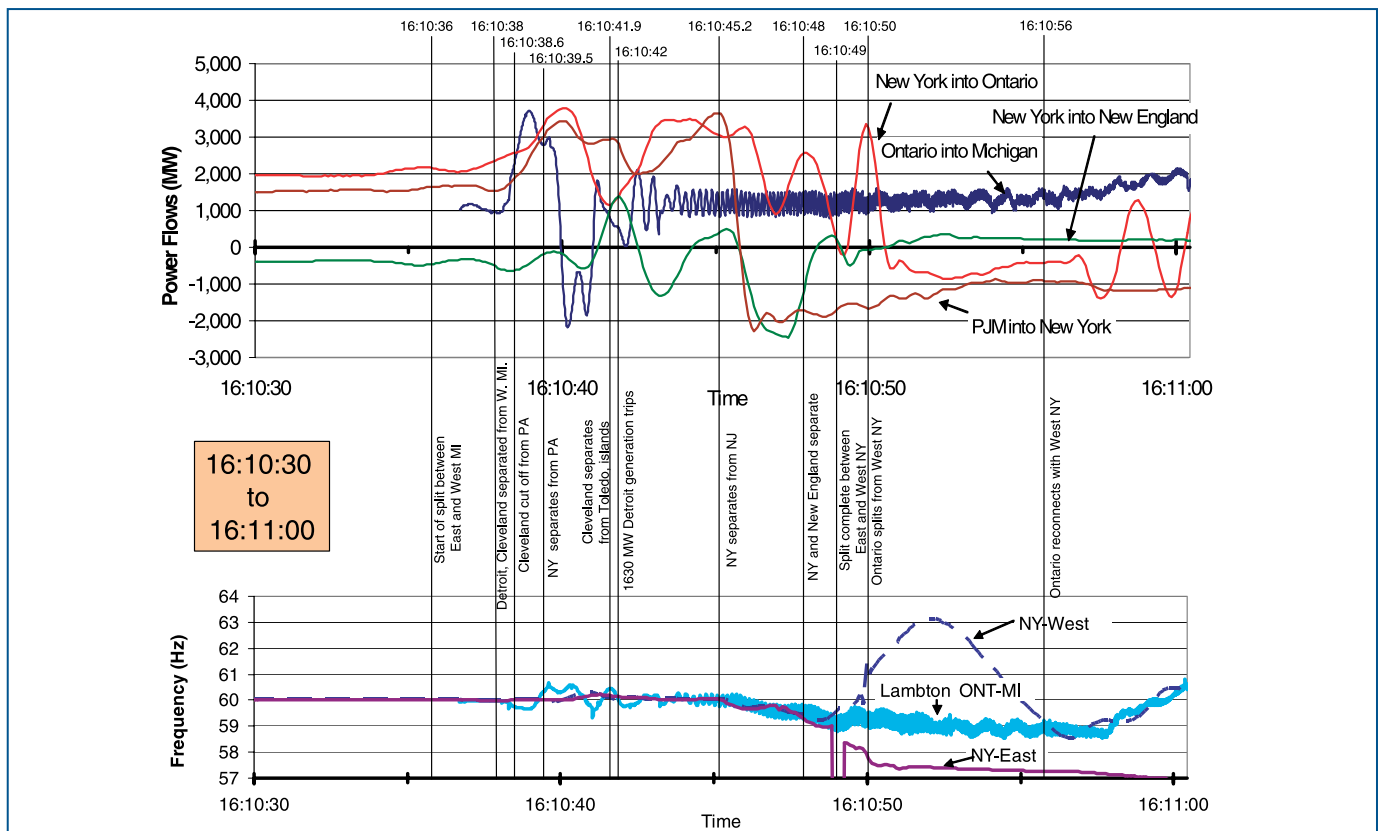
Figure 6.17. Measured Power Flows and Frequency Across Regional Interfaces, 16:10:30 to 16:11:00 EDT, with Key Events in the Cascade

After Cleveland was cut off from Pennsylvania and eastern power sources, Figure 6.17 shows the start of the dynamic power swing at 16:10:38.6. Because the loads of Cleveland, Toledo and Detroit (less the load already blacked out) were now hanging off Michigan and Ontario, this forced a gigantic shift in power flows to meet that demand. As noted above, flows from Ontario into Michigan increased from 1,000 MW to 3,700 MW shortly after the start of the swing, while flows from PJM into New York were close behind. But within two seconds from the start of the swing, at 16:10:40 EDT flows reversed and coursed back from Michigan into Ontario at the same time that frequency at the interface dropped, indicating that significant generation had been lost. Flows that had been westbound across the Ontario-Michigan interface by over 3,700 MW at 16:10:38.8 dropped down to 2,100 MW eastbound by 16:10:40, and then returned westbound starting at 16:10:40.5.

Re-examination of Figure 6.17 shows the power swing from the northeast through Ontario into Michigan and northern Ohio that began at 16:10:37, and how it reverses and swings back around Lake Erie at 16:10:39 EDT. That return was caused by the combination of natural oscillations, accelerated by major load losses, as the northern Ohio system disconnected from Michigan. It caused a power flow change of 5,800 MW, from 3,700 MW westbound to 2,100 eastbound across the Ontario to Michigan border between 16:10:39.5 and 16:10:40 EDT. Since the system was now fully dynamic, this large oscillation eastbound would lead naturally to a rebound, which began at 16:10:40 EDT with an inflection point reflecting generation shifts between Michigan and Ontario and additional line losses in Ohio.

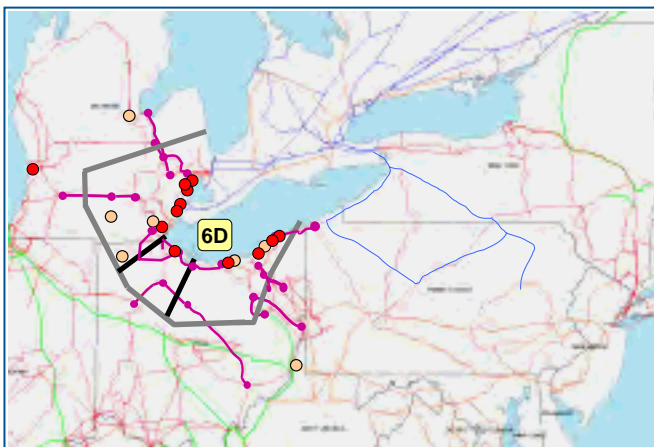
Back in northern Ohio, the trips of the Bay Shore-Monroe, Majestic-Lemoyne, Allen Junction-Majestic-Monroe 345-kV lines, and the Ashtabula 345/138-kV transformer cut off Toledo and Cleveland from the north, turning that area into an electrical island (Figure 6.18). Frequency in this large island began to fall rapidly. This caused a series of power plants in the area to trip

The Perry nuclear plant is in Ohio on Lake Erie, not far from the Pennsylvania border. The Perry plant was inside a decaying electrical island, and the plant tripped on under-frequency, as designed. A number of other units near Cleveland tripped off-line by under-frequency protection.

Figure 6.18. Cleveland and Toledo Islanded, 16:10:39 to 16:10:46 EDT

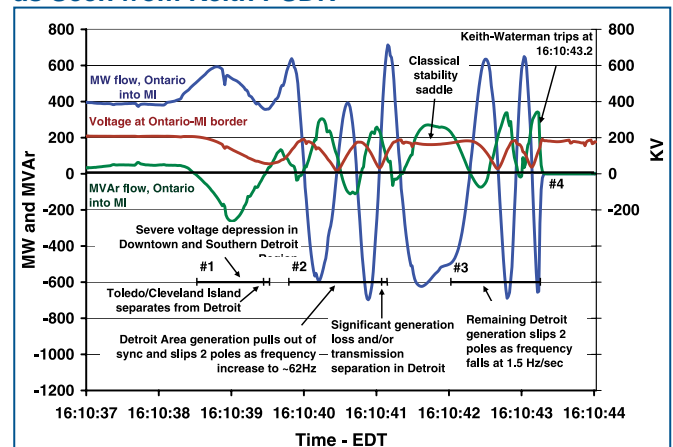
The tremendous power flow into Michigan, beginning at 16:10:38, occurred when Toledo and Cleveland were still connected to the grid only through Detroit. After the Bay Shore-Monroe line tripped at 16:10:39, Toledo-Cleveland were separated into their own island, dropping a large amount of load off the Detroit system. This left Detroit suddenly with excess generation, much of which was greatly accelerated in angle as the depressed voltage in Detroit (caused by the high demand in Cleveland) caused the Detroit units to pull nearly out of step. With the Detroit generators

running at maximum mechanical output, they began to pull out of synchronous operation with the rest of the grid. When voltage in Detroit returned to near-normal, the generators could not fully pull back its rate of revolutions, and ended up producing excessive temporary output levels, still out of step with the system. This is evident in Figure 6.19, which shows at least two sets of generator “pole slips” by plants in the Detroit area between 16:10:40 EDT and 16:10:42 EDT. Several large units around Detroit—Belle River, St. Clair, Greenwood, Monroe, and Fermi—all tripped in response. After formation of the Cleveland-Toledo island at 16:10:40 EDT, Detroit frequency spiked to almost 61.7 Hz before dropping, momentarily equalized between the Detroit and Ontario systems, but Detroit frequency began to decay at 2 Hz/sec and the generators then experienced under-speed conditions.

Figure 6.19. Generators Under Stress in Detroit, as Seen from Keith PSDR
